DEPARTMENT OF TRANSPORTATION

Contract #: 04-0120F4Cty: SF/ALA Rte: 80 PM: 13.2/13.9File #: 69.28**WELDING INSPECTION REPORT****Resident Engineer:** Siegenthaler, Peter**Address:** 333 Burma Road**City:** Oakland, CA 94607**Report No:** WIR-020621**Date Inspected:** 11-Feb-2011**Project Name:** SAS Superstructure**OSM Arrival Time:** 1900**Prime Contractor:** American Bridge/Fluor Enterprises, a JV**OSM Departure Time:** 700**Contractor:** Zhenhua Port Machinery Company, Ltd (ZPMC), Changxing Island **Location:** Shanghai, China**CWI Name:** Mr. Sha Zhi**CWI Present:** Yes No**Inspected CWI report:** Yes No N/A**Rod Oven in Use:** Yes No N/A**Electrode to specification:** Yes No N/A**Weld Procedures Followed:** Yes No N/A**Qualified Welders:** Yes No N/A**Verified Joint Fit-up:** Yes No N/A**Approved Drawings:** Yes No N/A**Approved WPS:** Yes No N/A**Delayed / Cancelled:** Yes No N/A**Bridge No:** 34-0006**Component:** OBG**Summary of Items Observed:**

OBG Bay 14

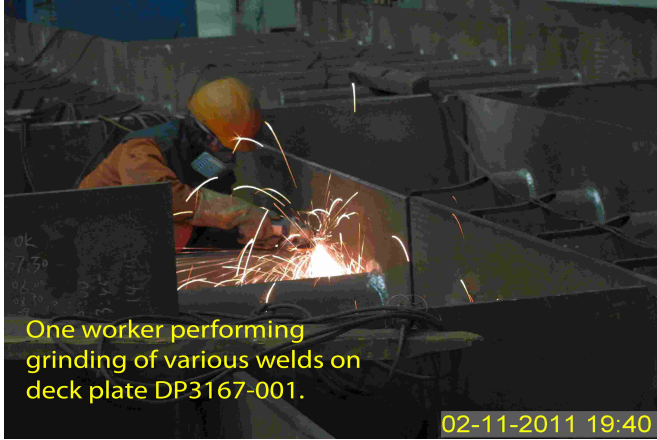
This QA Inspector observed ten (10) ZPMC personnel performing grinding of welds at various locations on OBG segments 13E and 14E. See the photograph below for additional information.
